Name Of Dam: LOWER NORTH RIVER NO. 81C
Location: ROCKINGHAM COUNTY, STATE OF VIRGINIA
Inventory Number: VA 16506

PHASE I INSPECTION REPORT

NATIONAL DAM SAFETY PROGRAM

Name of Dam: Lower North River Dam No. 81C
State: Virginia
County: Rockingham
Stream: Skidmore Fork
Date of Inspection: 14 June 1978

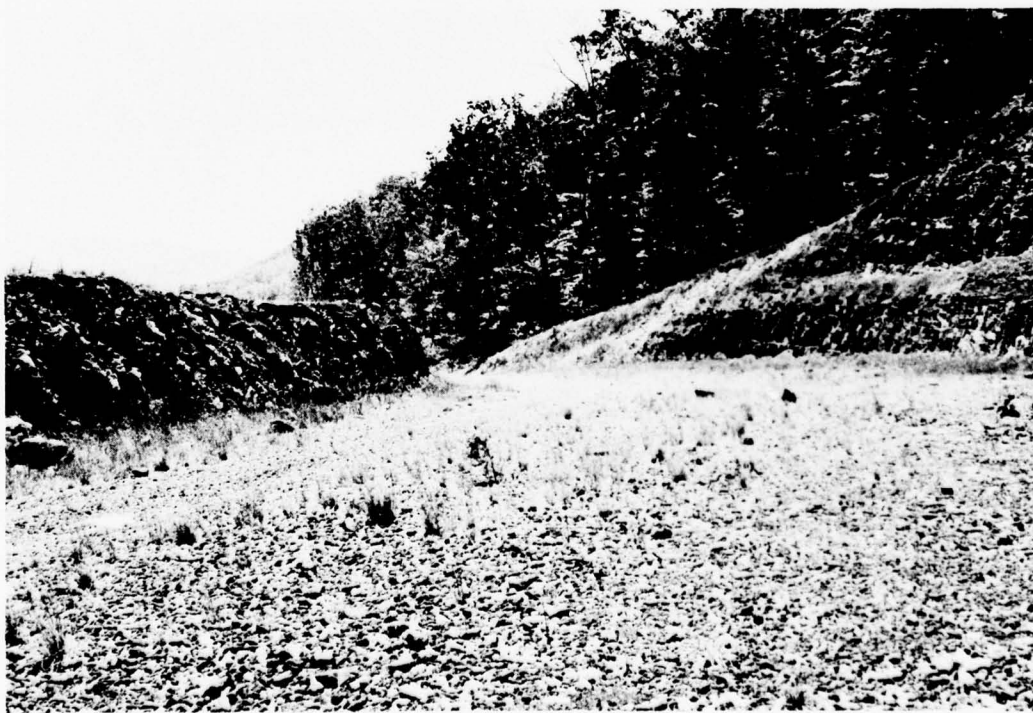
PHOTO 2

3.1.3 Appurtenant Structures: The inlet and outlet structures appeared to be in very good physical condition and functioning properly. The emergency spillway is also in good condition (see Photo 2).

VISUAL EXAMINATION OF		OBSERVATIONS	REMARKS OR RECOMMENDATIONS
CONCRETE WEIR		There are none.	
APPROACH CHANNEL		The approach channel to the emergency spillway is primarily rock-cut with some compacted fill with very little vegetation and on an adverse two percent slope. The bottom width is about 100 feet with 0.5:1 side slopes forming a trapezoidal shape. The bedrock consists of jointed hard sandstone and medium siltstone. See Photo 1.	
DISCHARGE CHANNEL		The discharge channel is cut in primarily sandstone and siltstone with trapazoidal shape 100 feet wide and on a positive two percent slope. The channel banks are ripped where bedrock is absent. The channel discharges along a small water course on the left abutment with an adjacent road (see Photo 1).	
BRIDGE AND PIERS		There are none.	
CUT SLOPES		Red and gray hard sandstone with some medium hard siltstone and thin soft clay shale seams were observed in the cut slopes. The bedding planes vary from a horizontal to 70 undulating dip. There are two sets of steep to vertical joint systems. The cut slopes on both sides were made at a 0.5:1 ratio and appear to be stable with minor amounts of small rock talus. See Photos 1 and 2.
